## CHANCE BROOK DAM

NH 00410

### PHASE I INSPECTION REPORT NATIONAL DAM INSPECTION PROGRAM

AUGUST 1978

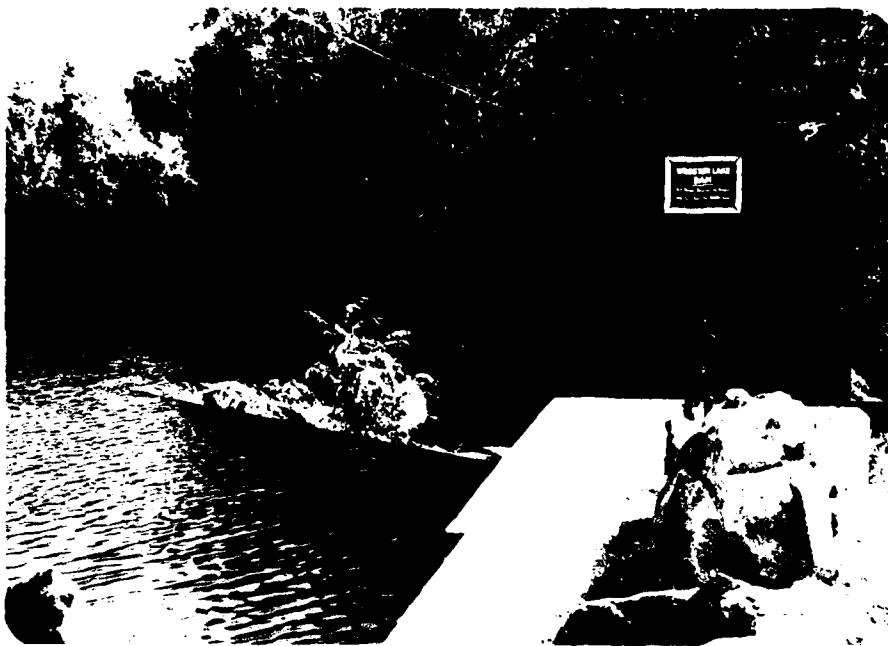
Overview from right abutment

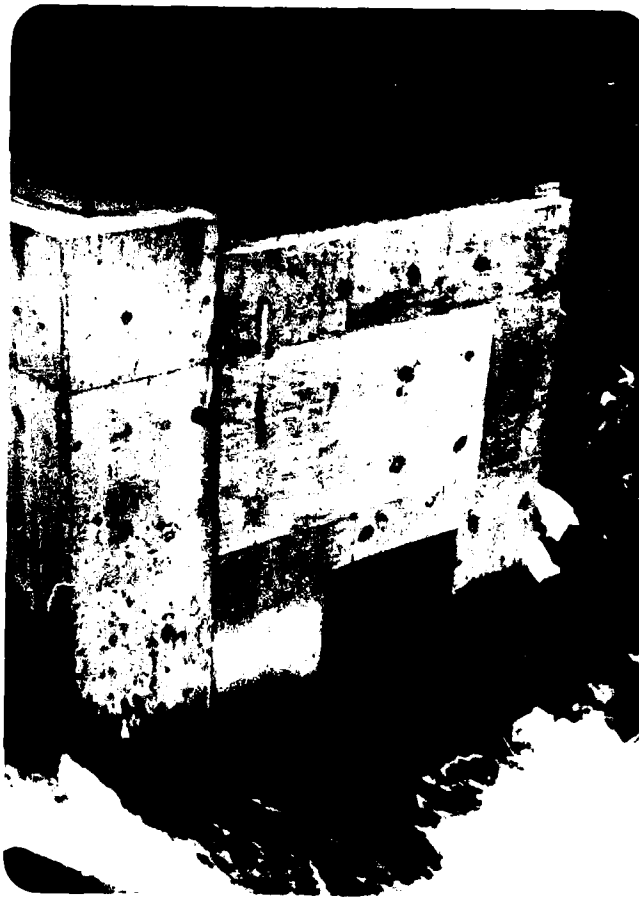
2. Detail of gatehouse outlet from downstream right side

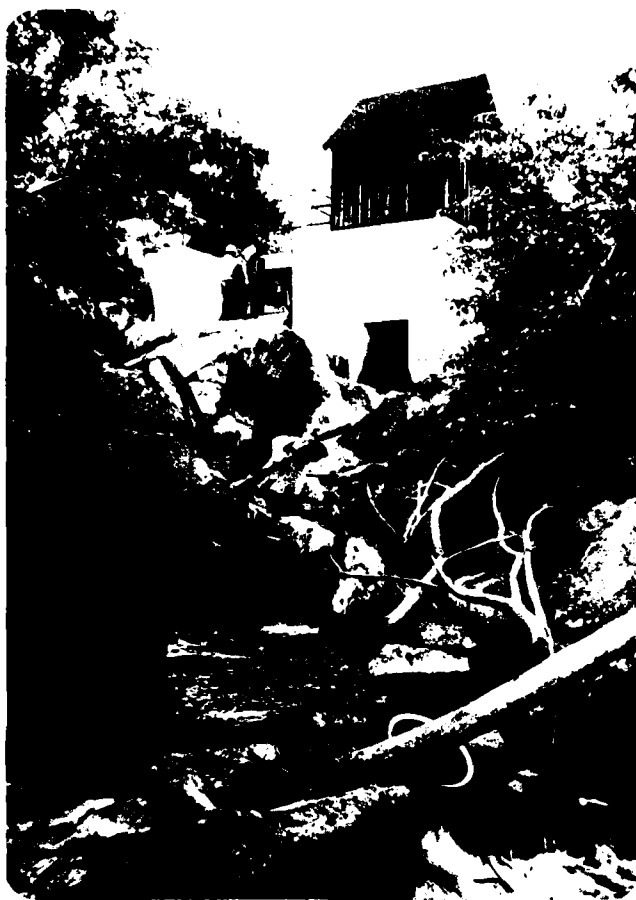
5. View of gatehouse and debris from downstream channel

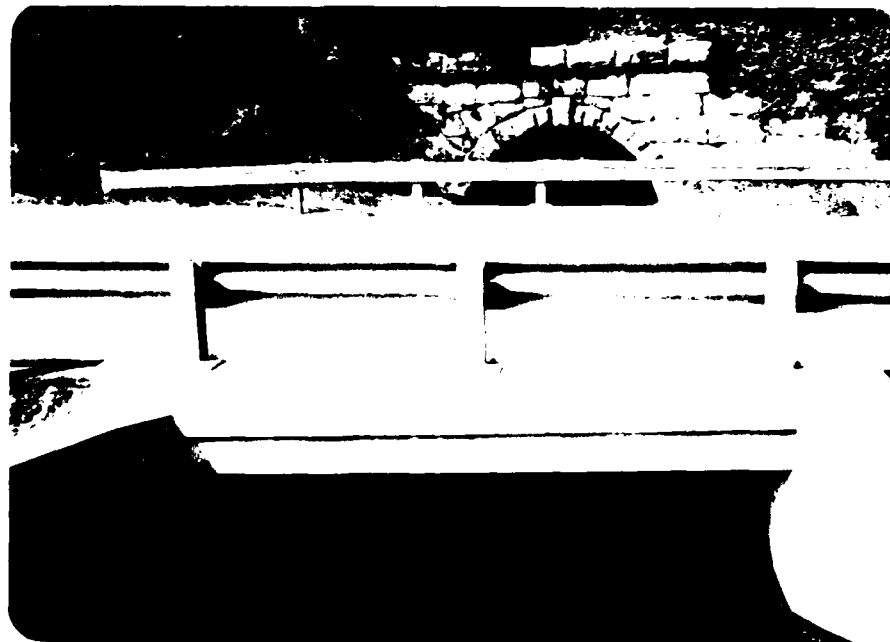
Several constrictions in Chance Brook between Webster Lake and Chance Brook Dam were noted during the inspection visit. These constrictions could very well reduce the flow capacity in the brook and cause high water levels in Webster Lake during small floods. Only the Boston and Maine railroad bridge would severely restrict flows during a severe flood such as the Spillway Test Flood. All of the others would be overtopped and thus not significantly affect the flows reaching the dam. Basic data on these constrictions is as follows:

7. View from upstream of road bridge and railroad bridge near lake outlet

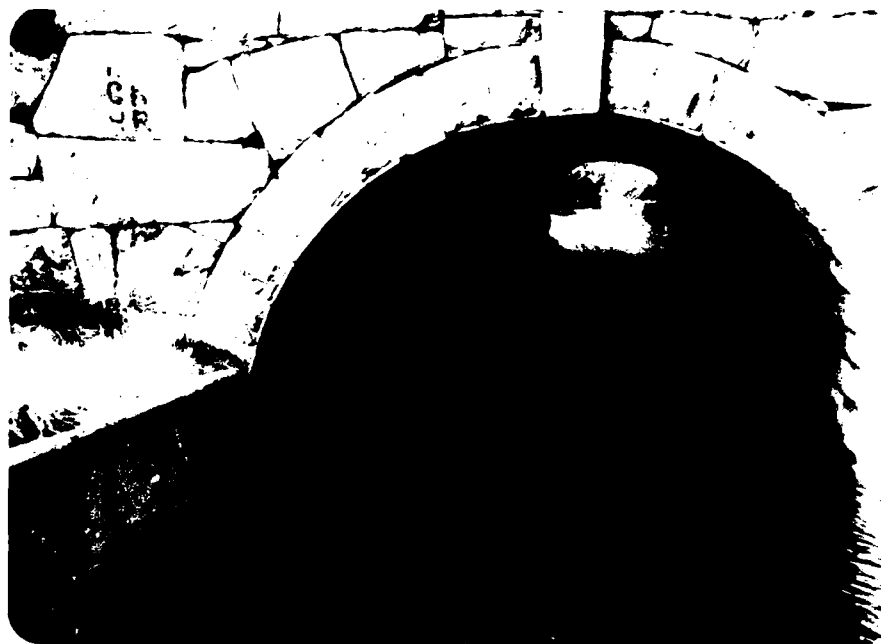
Thus, as long as the railway dike which separates Webster Lake from Chance Pond holds, there seems to be little likelihood of overtopping Chance Brook Dam. However, if this dike were to fail, the dam would almost certainly be overtopped.

8. View from upstream of railroad culvert near lake outlet

The sluice gate operating mechanism support should be repaired by the owner, and the railroad embankment should be investigated within the next two to three years after receipt of the Phase I Investigation Report.

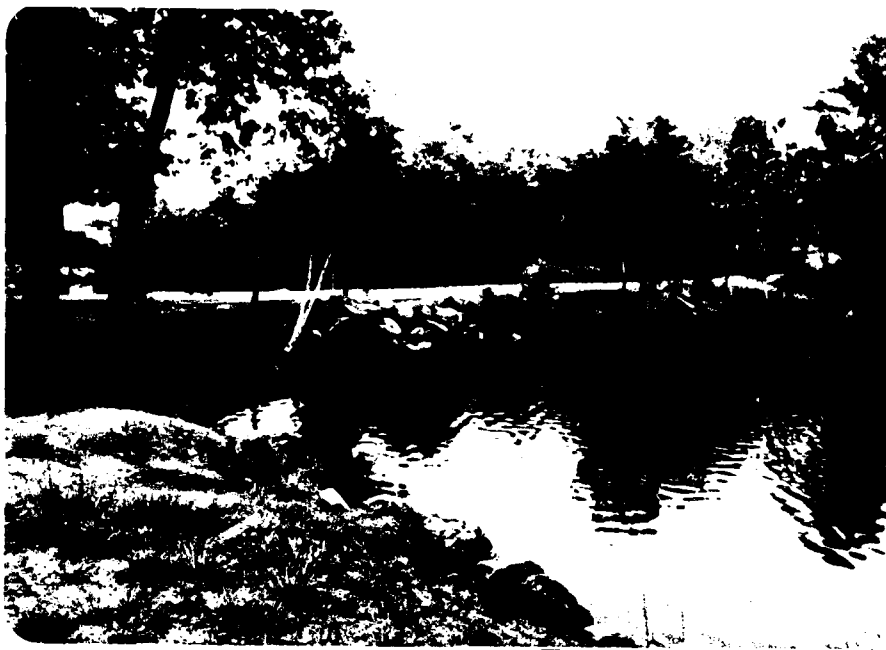
9. View from downstream of Carr St. culvert
